OKEMO MOUNTAIN ACCESS RD CULVERT REPLACEMENT

TOWN OF LUDLOW, VERMONT

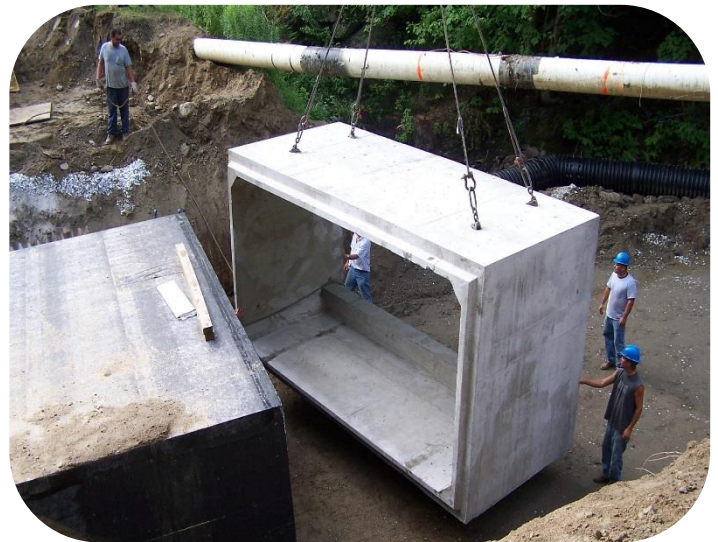
Construction Phase

The culvert design also had to accommodate existing water, sewer, and buried communications conduits routed up the access road. After reviewing the options, a precast culvert replacement was selected.

There were significant challenges with the culvert design to meet the Fish and Wildlife criteria for fish passage. The final solution was to construct the culvert with interior stilling basins to trap natural stream materials and provide riprap along the culvert walls to provide fish resting areas.

- Project constructed in approximately 20 days with minimal traffic disturbance.
- Designed to meet Fish & Wildlife criteria for aquatic organism and fish passage.
- Minimal stream alteration with stream flows maintained during construction.
- 16' x 8' culvert provides approximately double the original hydraulic capacity.
- Wastewater flows maintained by sewer bypass pumping system.
